# Atlantic Richfield Company

**RE: Leviathan Mine Site: Update on Limited Access      Season Site Conditions**  
**April 5 - 12, 2017**

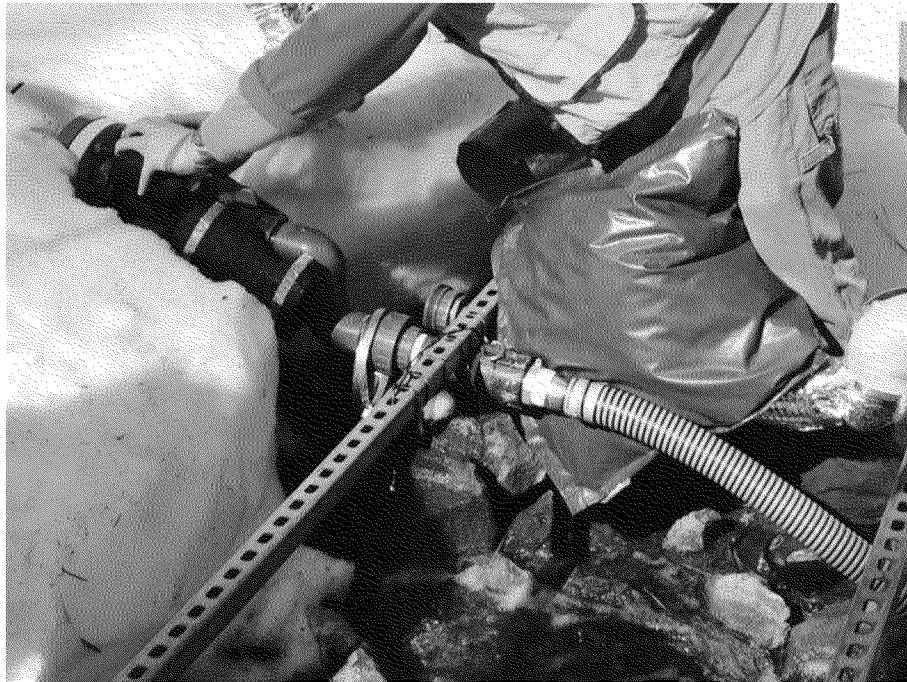
April 6, 2016: Replacement 2-inch effluent line discharging to aeration channel.

Copper Environmental personnel accessed the ASB on April 6, 2017. Personnel cleared debris from the Pond 4 effluent launder, increased the diameter of the outlet piping from 1-inch to 2-inch, and disconnected the 1-inch in-line flow meter. They also pumped approximately 21,000 gallons of treated water out of ASB-Pond 4 to the aeration channel to lower the pond water level. Treated effluent continued to discharge from ASB-Pond 4 to the aeration channel following these modifications.

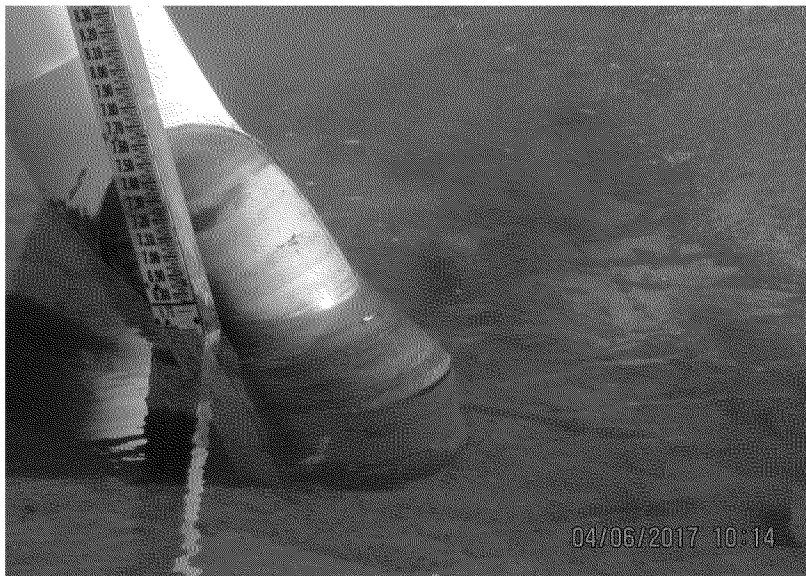
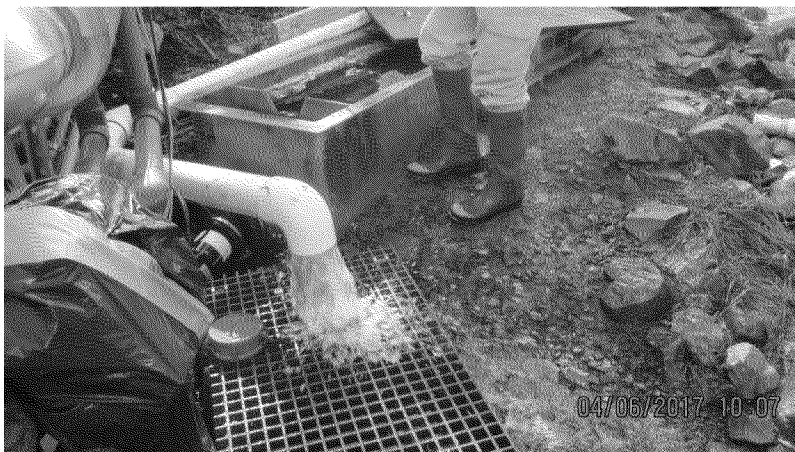
On April 6, 2017, at approximately 3:30 PM PDT, Atlantic Richfield received word from the LRWQCB that a connection on the overflow riser pipe assembly in Pond 4 (near the HDS

treatment building) had separated a few inches below the water line, and as a result, water was discharging through the overflow pipe to Leviathan Creek. Photographs sent by the LRWQCB are shown below:

It appeared from the photos that the separation may have resulted from ice pushing against the riser pipe assembly. Atlantic Richfield does not normally have personnel at the site at this time of year, and the pipe separation was not the result of any human-caused activity. It also appeared that there were only a few inches of standing water in Pond 4 above the pipe separation, and the section of pipe below the separation was intact. According to Doug Carey, LRWQCB Board crews who were at the site earlier in the week did not observe any discharge from the Pond 4 overflow pipe, so we assume the separation occurred sometime between April 4 and April 6, 2017. pH measurements from EPA's data sonde in Leviathan Creek at 4L did not suggest that the resulting discharge from Pond 4 was having any significant effect on surface water quality during this time:

At 5:49 PM PDT on April 6, 2017, Atlantic Richfield notified EPA of these conditions by email. Atlantic Richfield also described its plan for repairing the pipe separation by sending field personnel to the site the following day, weather permitting.

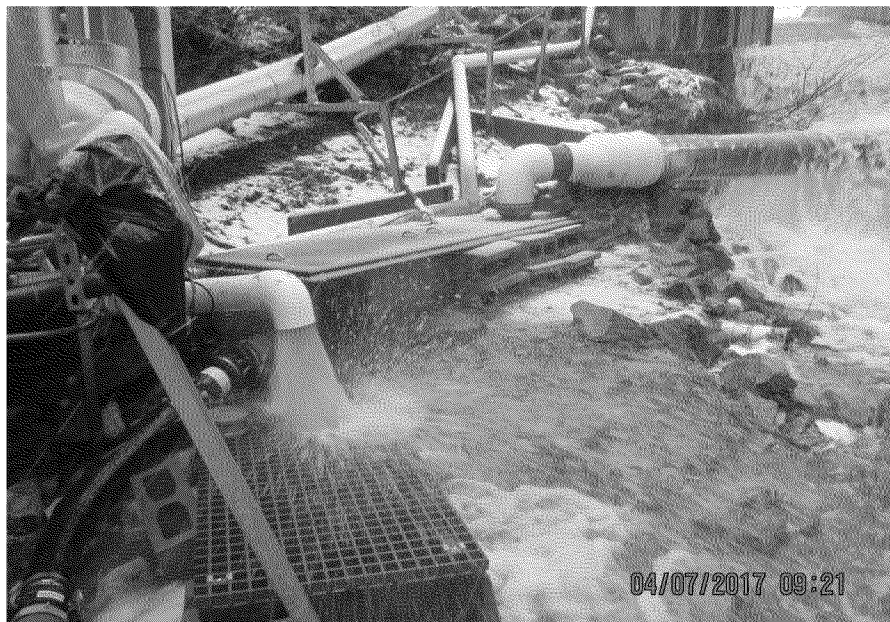
April 7, 2017: Overflow pipe discharge while Pond 4 pipe riser assembly was being removed and re-set.

On April 7, 2017, Copper Environmental field personnel entered the site, despite poor weather conditions (sleet and snow). Personnel waded into Pond 4 and re-set the overflow pipe riser assembly into the lower pipe receiver as best they could. Personnel also placed temporary sandbags around the pipe riser assembly in an attempt to stabilize the piping. Discharge from Pond 4 through the discharge pipe increased briefly while the pipe riser assembly was being removed and then reset. After resetting the assembly, the discharge rate decreased, but flow was not completely stopped. As a result, Copper began formulating plans for additional, more permanent repairs to the pipe riser assembly to be made the following week.

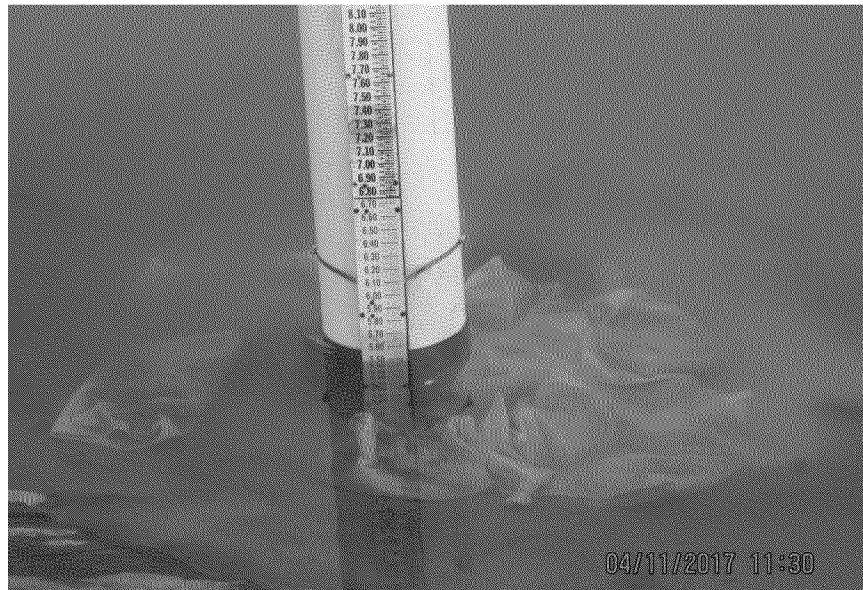
April 11, 2017: Repaired pipe riser assembly. Pond water level at 5.50'.

On April 11, 2017, crews returned to the site to complete more permanent repairs to the Pond 4 pipe riser assembly. A new stand pipe was inserted into the lower pipe receiver and better stabilized with appropriate fittings and clamps. The pond water level staff gage was also re-set, and some of the sand bags were removed. Following these additional repairs, no flow was observed from the discharge pipe outlet. Photographs showing conditions following these additional repairs are provided below:

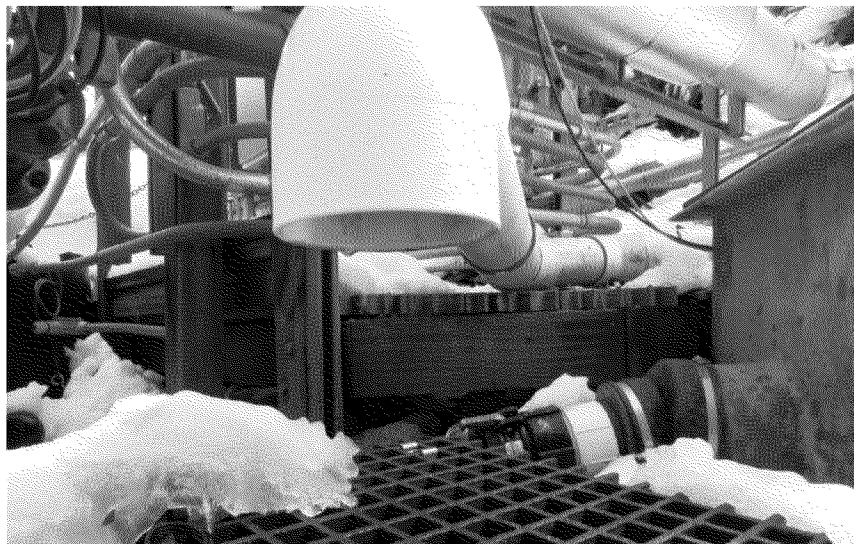
April 11, 2017: Discharge pipe outlet following repairs to pipe riser assembly.
